**Flood Control Project Maintenance  
Levee Inspections****LMA District Cover Sheet****Spring 2016 Levee Inspection Results****Reclamation District No. 0349 Sutter Island**

**Levee Inspection Report By Mile - Spring 2016**

**Reclamation District No. 0349 Sutter Island**

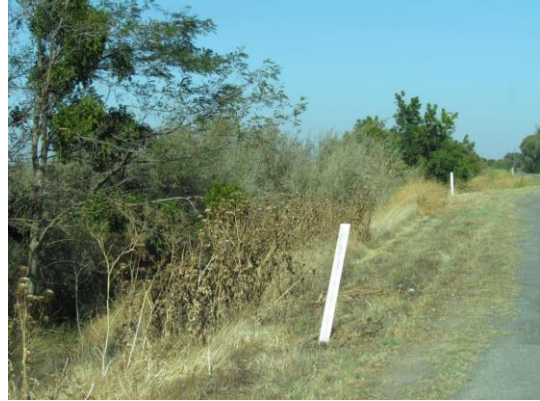
Photo 1 of 1 : SP\_2016\_RD0349\_206\_67\_20160223\_00007.jpg

LM Start	2.52	Rating **	U	Issue No.	67
LM End	2.72	Issue Type +	Ma	Location *	WS
Category	Earthen Levee			GPS Latitude/Longitude	
				Start	End
Item	Vegetation			38.288948 °	38.291873 °
				-121.603282 °	-121.603645 °
DWR ID	DWR_RD0349_03_f _ 2015_67				
Comment Code					
V1 : Control annual grass and weeds on the levee slopes and easements.					
Inspector Comment					
Remove this unsatisfactory wild growth of vegetation from the waterside shoulder and slope.

Looking downstream waterside shoulder and slope at unsatisfactory tall weeds and woody tree growth blocking the view of the levee section.

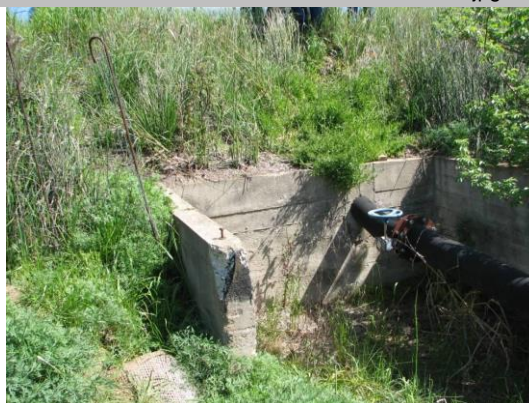
Photo 2 of 2 : UCIP\_SP\_2016\_43424\_36871.jpg

FS\_ID:43424  
DS\_ID:24177  
EP\_NO: N/A  
Repair Type: Non-Urgent  
Crossing Status: Found  
UCIP Comments: 2007 Erosion Repair Site location?--Need to contact owner to determine if crossing is still in use. If crossing is no longer used by owner, the owner will need to coordinate with DWR Inspector and CVFPB to remove crossing according to Title 23 requirements. Dense vegetation limits the inspector's visibility to identify signs of pipe failure (leaks) through the levee slopes. Recommend removing vegetation along pipe alignment to conduct proper inspection of structure and appurtenances. Note date on photos should be 3/18/09 not 7/26/08 camera metadata is incorrect.  
FIELD\_STRUCT\_DESC: Abandoned 8-inch pipe through the levee, 8.7 feet below the crown. Headwall and gate valve on the landward side.  
FS Date: 3/19/2009

View of waterward side--headwall, pipe, and gate valve.

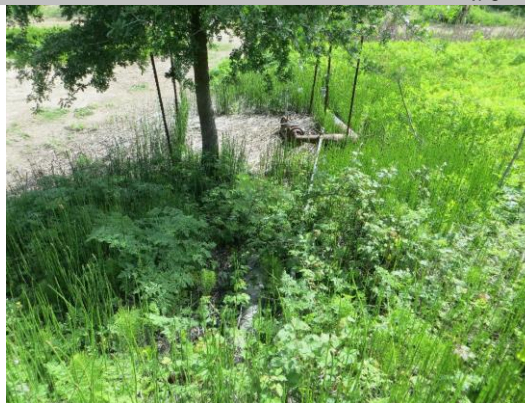
Photo 1 of 2 : UCIP\_SP\_2016\_44387\_73743.jpg

LM Start	2.88	Rating **	U	Issue No.	992
LM End	2.88	Issue Type +	En	Location *	WS
Category	Supplemental			GPS Latitude/Longitude	
				Start	End
Item	DWR UCIP Field Study			38.294080 °	38.294080 °
				-121.604260 °	-121.604260 °
DWR ID					
Comment Code					
Inspector Comment					
FS_ID:44387 DS_ID:24178 EP_NO: 6321 Repair Type: Urgent Crossing Status: Found UCIP Comments: Appears abandoned and if so should be done so properly. Pipe open at LS toe. Unable to verify if plate is welded over WS end. FIELD_STRUCT_DESC: Abandoned 8-inch steel irrigation pipe through the levee, 4.5 feet below the crown. CM cutoff wall around pipe at center of levee. Siphon breaker on waterward shoulder. Pump on landward side. Gate valve on the waterward side. 1.5-inch filler pipe at same location. Plate welded to waterward end (Permit No. 6321-1969). FS Date: 4/9/2015

Pipe and pump platform on LS toe.

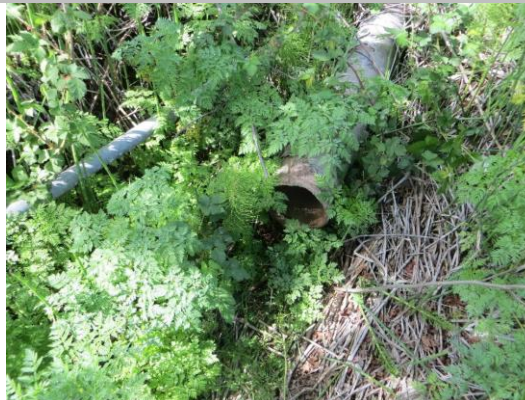
Photo 2 of 2 : UCIP\_SP\_2016\_44387\_73742.jpg

1.5-inch filler pipe and 8-inch steel irrigation pipe at LS toe.

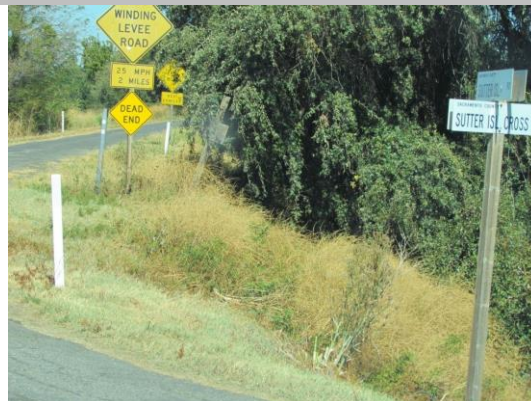
Photo 1 of 1 : SP\_2016\_RD0349\_206\_72\_20160223\_00008.jpg

LM Start	3.00	Rating **	U	Issue No.	72
LM End	6.50	Issue Type +	Ma	Location *	LS
Category	Earthen Levee			GPS Latitude/Longitude	
				Start	End
Item	Vegetation			38.295798 °	38.327002 °
				-121.604735 °	-121.576920 °
DWR ID	DWR_RD0349_03_f_2015_72				
Comment Code					
V1 : Control annual grass and weeds on the levee slopes and easements.					
Inspector Comment					
This section hasn't been maintained and is completely overgrown. No maintenance since 2015 inspection.

Unsatisfactory tall weeds and vegetation on the landside levee slope and shoulder runs from levee mile 3.00 to 6.50.

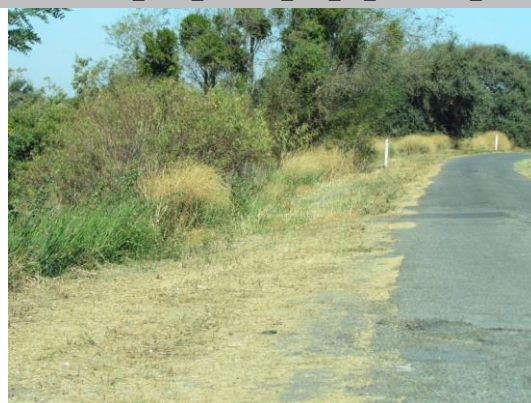
Photo 1 of 1 : SP\_2016\_RD0349\_206\_74\_20160223\_00011.jpg

LM Start	3.01	Rating **	U	Issue No.	74
LM End	6.50	Issue Type +	Ma	Location *	WS
Category	Earthen Levee			GPS Latitude/Longitude	
				Start	End
Item	Vegetation			38.296030 °	38.327002 °
				-121.604710 °	-121.576920 °
DWR ID	DWR_RD0349_03_f_2015_74				
Comment Code					
V1 : Control annual grass and weeds on the levee slopes and easements.					
Inspector Comment					
Looking downstream from the waterside levee slope at unsatisfactory vegetation. No maintenance since last inspection.

Looking downstream waterside, unsatisfactory tall vegetation blocking view of the levee slope.

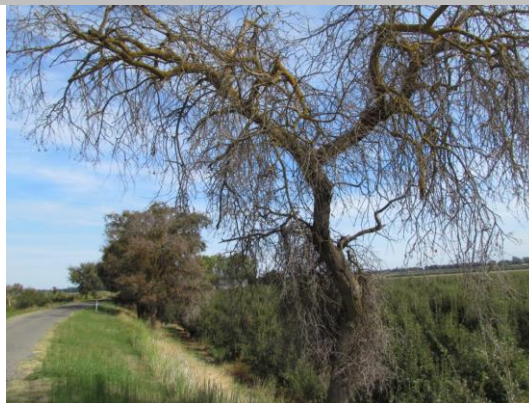
Photo 1 of 2 : SP\_2016\_RD0349\_206\_73\_20160223\_00009.jpg

Dead tree above crown roadway landward.

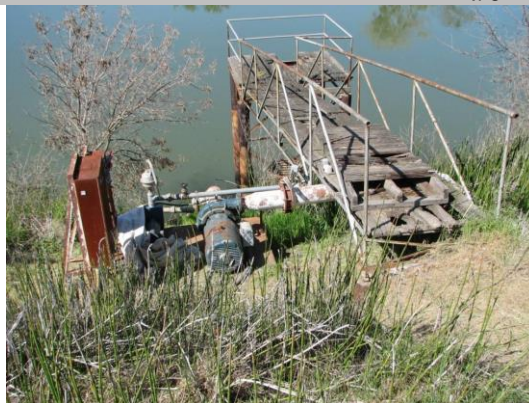
Photo 1 of 2 : UCIP\_SP\_2016\_44389\_36873.jpg

LM Start	3.34	Rating **	M	Issue No.	995
LM End	3.34	Issue Type +	En	Location *	LS
Category	Supplemental			GPS Latitude/Longitude	
				Start	End
Item	DWR UCIP Field Study			38.299703 °	38.299703 °
				-121.601112 °	-121.601112 °
DWR ID					
Comment Code					
Inspector Comment					
FS_ID:44389 DS_ID:24179 EP_NO: N/A Repair Type: Non-Urgent Crossing Status: Found UCIP Comments: Crossing altered--need to contact owner to obtain permit number authorizing work. Dense vegetation limits the inspector's visibility to identify signs of pipe failure (leaks) along the slope. Recommend removing vegetation along pipe alignment to conduct proper inspection of structure and appurtenances. Note date on photos should be 3/18/09 not 7/26/08 camera metadata is incorrect. FIELD_STRUCT_DESC: *DELETE* FS Date: 4/9/2015

View of waterward side--pump, control panel, pipe, and walkway.

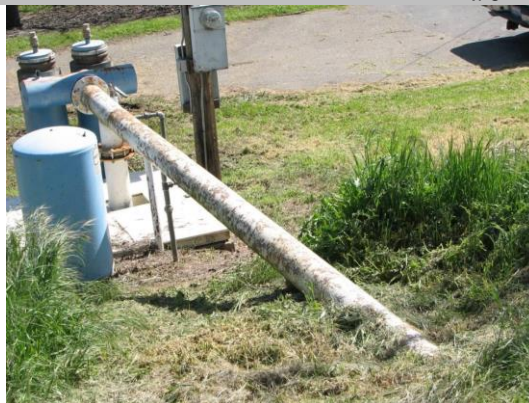
Photo 1 of 2 : UCIP\_SP\_2016\_44390\_73745.jpg

LM Start	3.34	Rating **	M	Issue No.	996
LM End	3.34	Issue Type +	En	Location *	LS
Category	Supplemental			GPS Latitude/Longitude	
				Start	End
Item	DWR UCIP Field Study			38.299718 °	38.299718 °
				-121.601095 °	-121.601095 °
DWR ID					
Comment Code					
Inspector Comment					
FS_ID:44390					
DS_ID:24214					
EP_NO: N/A					
Repair Type: Non-Urgent					
Crossing Status: Found					
UCIP Comments: Walway and pier abandoned and appears to be a hazard that should be removed.					
FIELD_STRUCT_DESC: 10-inch steel irrigation pipe through the levee 5.8-feet below the crown. Pump, butterfly valve, and electrical panel on WS slope. Pier and walkway next to pump on WS slope. Power pole, filters, and distribution box at LS toe.					
FS Date: 4/9/2015

Pipe, filter system, powerpole, and distribution box at LS toe.

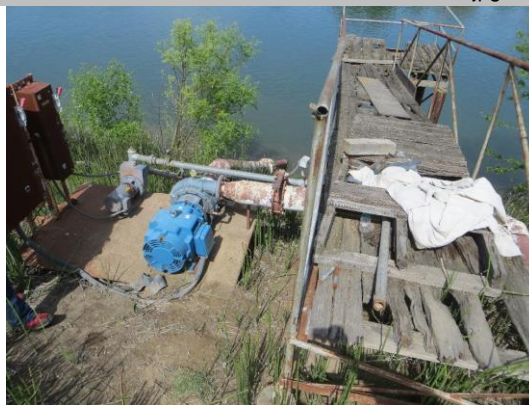
Photo 2 of 2 : UCIP\_SP\_2016\_44390\_73746.jpg

Pump, electrical panel, butterfly valve, and walkway on WS slope.

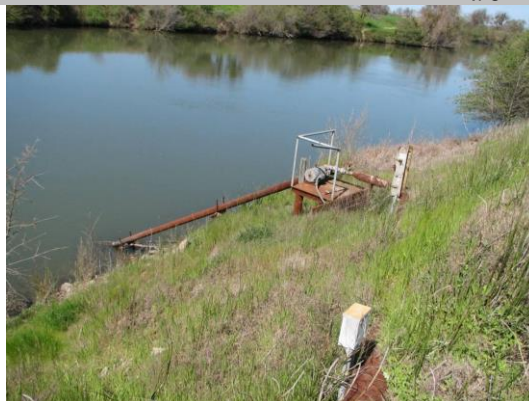
Photo 1 of 2 : UCIP\_SP\_2016\_21644\_36780.jpg

Comment Code					
Inspector Comment					
FS_ID:21644					
DS_ID:24180					
EP_NO: 9290					
Repair Type: Non-Urgent					
Crossing Status: Found					
UCIP Comments: Dense vegetation limits the inspector's visibility to					
identify signs of pipe failure (leaks) through the levee slopes.					
Recommend removing vegetation along pipe alignment to conduct					
proper inspection of structure and appurtenances.					
FIELD_STRUCT_DESC: 10-inch steel pipe and 1.5-inch steel electrical					
conduit through the levee, both 4.0 feet below the crown. Steel cutoff					
wall around pipe and conduit at center of levee. Pump and gate valve					
on waterward slope. 6-inch intake pipe extends from pump into channel.					
Distribution system at landward toe. (Permit No. 9290-1975)					
FS Date: 3/19/2009

View of waterward side.

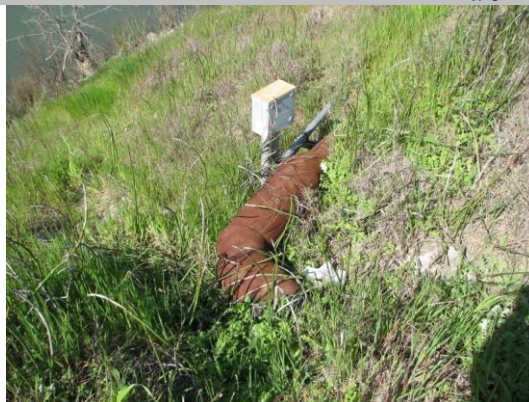
Photo 2 of 2 : UCIP\_SP\_2016\_21644\_36778.jpg

90 elbow at daylight and continues along slope and connects to pump.

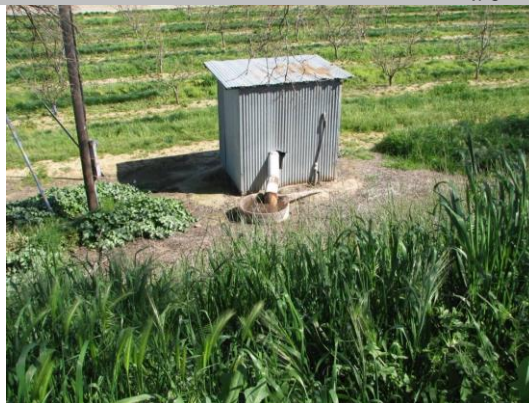
Photo 1 of 2 : UCIP\_SP\_2016\_43455\_36783.jpg

Comment Code					
Inspector Comment					
FS_ID:43455 DS_ID:24201 EP_NO: 15503 Repair Type: Non-Urgent Crossing Status: Found UCIP Comments: Dense vegetation limits the inspector's visibility to identify signs of pipe failure (leaks) through the levee slopes. Recommend removing vegetation along pipe alignment to conduct proper inspection of structure and appurtenances. Note date on photos should be 3/18/09 not 7/26/08 camera metadata is incorrect. FIELD_STRUCT_DESC: 10-inch steel irrigation pipe through the levee, 3.0 feet below the crown. Steel cutoff wall around pipe 24-inches landward of levee center. Pump and gate valve in pumphouse at the landward toe. Pipe is exposed along waterward slope. (Permit No. 15503-1990) FS Date: 3/19/2009

Pump house located on landward side.

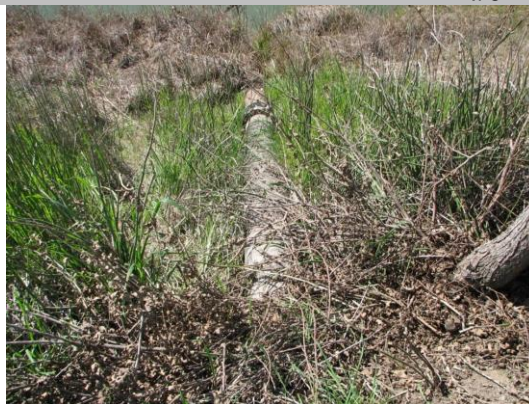
Photo 2 of 2 : UCIP\_SP\_2016\_43455\_36782.jpg

View of waterward side.

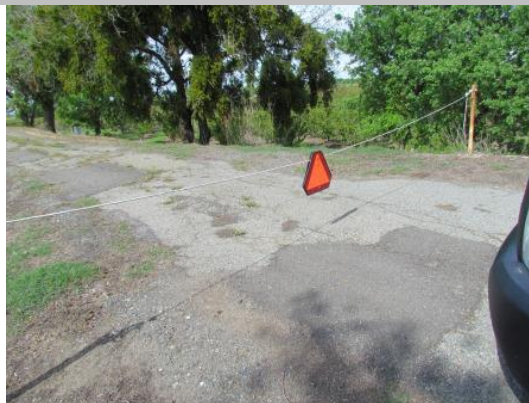
Photo 1 of 1 : SP\_2016\_RD0349\_206\_25\_20160223\_00002.jpg

LM Start	3.99	Rating **	U	Issue No.	25
LM End	3.99	Issue Type +	En	Location *	LS
Category	Earthen Levee			GPS Latitude/Longitude	
				Start	End
Item	Encroachments			38.307997 °	38.307997 °
				-121.597039 °	-121.597039 °
DWR ID	DWR_RD0349_03_s_2012_25				
Comment Code					
FE : Fence					
Inspector Comment					
Unauthorized cable gate crossing levee. Cable gates crossing the levee crown have been prohibited. There is no CVFPB permit for this crossing. This encroachment should be removed.

Cable crossings has been banned. They are unauthorized. No new photo.

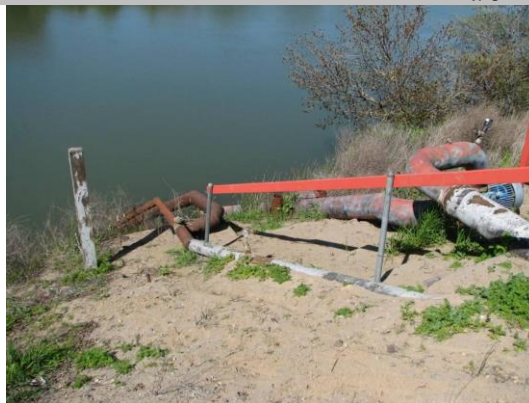
Photo 1 of 1 : UCIP\_SP\_2016\_43458\_36784.jpg

Comment Code					
Inspector Comment					
FS_ID:43458 DS_ID:24183 EP_NO: 8681 Repair Type: Non-Urgent Crossing Status: Found UCIP Comments: Need to contact owner to determine status of crossing. If crossing is no longer in use owner will need to coordinate with DWR inspector and CVFPB to remove according to Title 23 requirements. Dense vegetation limits the inspector's visibility to identify signs of pipe failure (leaks) through the levee slopes. Recommend removing vegetation along pipe alignment to conduct proper inspection of structure and appurtenances. Note date on photos should be 3/18/09 not 7/26/08 camera metadata is incorrect. FIELD_STRUCT_DESC: 1 of 2: 6-inch steel pipe and 1.5-inch steel electrical conduit through the levee, 4.1 feet and 2.0 feet below the crown, respectively. Steel cutoff wall around pipe and conduit at center of levee. Pump on platform and gate valve on the waterward slope, not connected. Exposed suction pipe from pump to channel. Rock revetment on waterward slope. (Permit No. 8681-1973) FS Date: 3/19/2009

View of waterward side. 2 crossing visible 12-inch and 6-inch pipes.

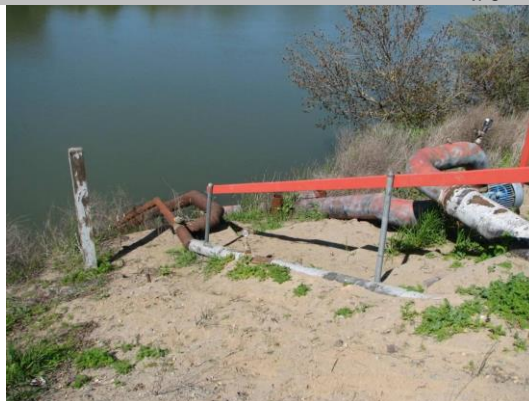
Photo 1 of 2 : UCIP\_SP\_2016\_43457\_36793.jpg

FS\_ID:43457  
DS\_ID:24184  
EP\_NO: 8681  
Repair Type: Non-Urgent  
Crossing Status: Found  
UCIP Comments: Need to contact owner. Is filter sytem located on landward side part of crossing. If so need permit number authorizing work. Also if crossing is no longer used by owner, the owner will need to coordinate with DWR Inspector and CVFPB to remove crossing according to Title 23 requirements. Dense vegetation limits the inspector's visibility to identify signs of pipe failure (leaks) through the levee slopes. Recommend removing vegetation along pipe alignment to conduct proper inspection of structure and appurtenances. Note date on photos should be 3/18/09 not 7/26/08 camera metadata is incorrect.  
FIELD\_STRUCT\_DESC: 2 of 2: 12-inch steel irrigation pipe through the levee, 4.3 feet below the crown. Steel cutoff wall around pipe at center of levee. Pump on platform and gate valve on the waterward slope. Exposed suction pipe from pump to channel. Rock revetment on waterward slope. (Permit No. 8681-1973)

View of waterward side. 2 crossing visible 12-inch and 6-inch pipes.

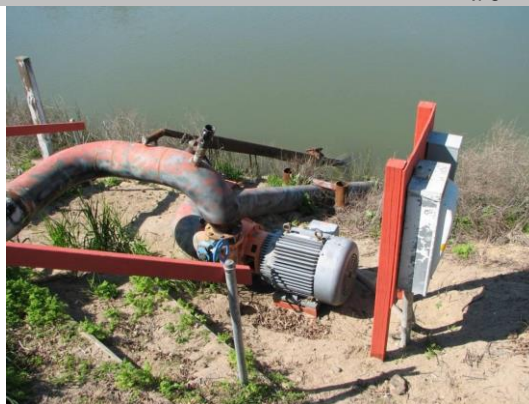
Photo 2 of 2 : UCIP\_SP\_2016\_43457\_36792.jpg

Pump associated with 12-inch pipe.

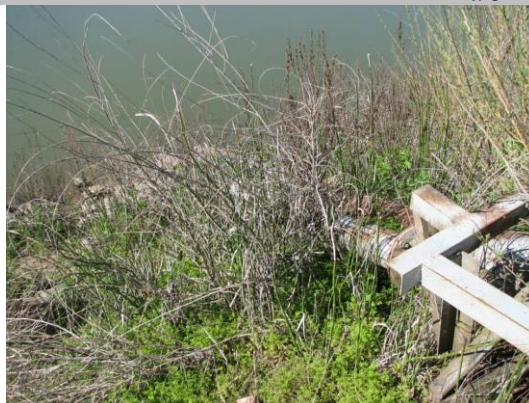
Photo 1 of 2 : UCIP\_SP\_2016\_43459\_36796.jpg

FS\_ID:43459  
DS\_ID:24185  
EP\_NO: N/A  
Repair Type: Non-Urgent  
Crossing Status: Found  
UCIP Comments: No connection present--need to contact owner to determine if owner plans to use. If crossing is no longer in use owner will need to coordinate with DWR inspector and CVFPB to remove according to Title 23 requirements. Recommend removing vegetation along pipe alignment. Note date on photos should be 3/18/09 not 7/26/08 camera metadata is incorrect.  
FIELD\_STRUCT\_DESC: 10-inch steel irrigation pipe and 2-inch electrical conduit through the levee, both 2.8 feet below the crown.  
Abandoned pumps and gate valve on the waterward slope. Service pole on the landward slope. Concrete headwall on landward side. (USACE-1959). This entry matches the Drainage or Irrigation Structure referenced in O&M manual (HLM 4.8).  
FS Date: 3/19/2009

Waterward side--pipe visible through dense vegetation.

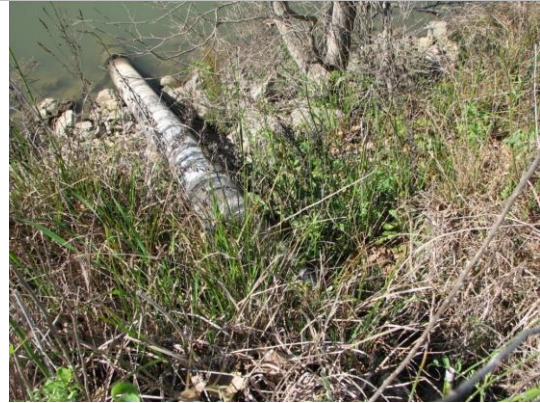
Photo 2 of 2 : UCIP\_SP\_2016\_43431\_36801.jpg

Item	DWR UCIP Field Study			38.316968 °	38.316968 °	
				-121.590219 °	-121.590219 °	
DWR ID						
Comment Code						
Inspector Comment						
FS_ID:43431 DS_ID:24186 EP_NO: 15359 Repair Type: Non-Urgent Crossing Status: Found UCIP Comments: Dense vegetation limits the inspector's visibility to identify signs of pipe failure (leaks) through the levee slopes. Recommend removing vegetation along pipe alignment to conduct proper inspection of structure and appurtenances. Note date on photos should be 3/18/09 not 7/26/08 camera metadata is incorrect. FIELD_STRUCT_DESC: 10-inch steel irrigation pipe through the levee, 6.0 feet below the crown. Siphon breaker in protective house at levee shoulder. Pump in pumphouse and power pole at landward toe. Pipe connected to 8-inch exposed pipe at landward shoulder, extending to pumphouse. Filter screen in channel at waterward toe. (Permit No. 15359-1990) FS Date: 3/19/2009

Pipe located on waterward side.

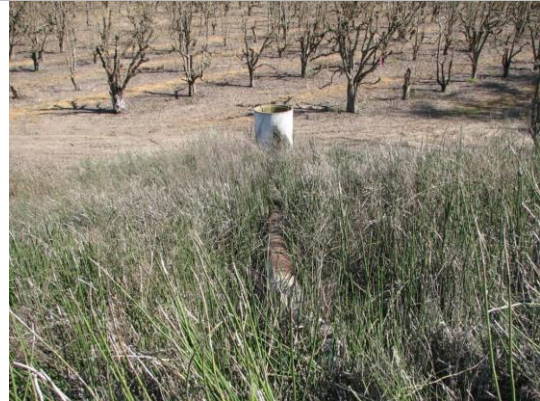
Photo 1 of 2 : UCIP\_SP\_2016\_43433\_70484.jpg

FS\_ID:43433  
DS\_ID:24188  
EP\_NO: N/A  
Repair Type: Non-Urgent  
Crossing Status: Found  
UCIP Comments: Walkway is no longer functional. Need to contact owner--if crossing is no longer used owner will need to coordinate with DWR Inspector and CVFPB. Dense vegetation limits the inspector's visibility to identify signs of pipe failure (leaks) through the levee slopes. Recommend removing vegetation along pipe alignment to conduct proper inspection of structure and appurtenances. Note date on photos should be 3/18/09 not 7/26/08 camera metadata is incorrect.  
FIELD\_STRUCT\_DESC: 12-inch pipe through the levee, 6.2 feet below the crown. Pump and control panel on piling structure in stream, with walkway. Service pole and concrete standpipe on the landward slope. (USACE-1959). This entry matches the Drainage or Irrigation Structure referenced in O&M manual (HLM 5.5).  
FS Date: 3/19/2009

View of landward side--pipe and stand pipe visible.

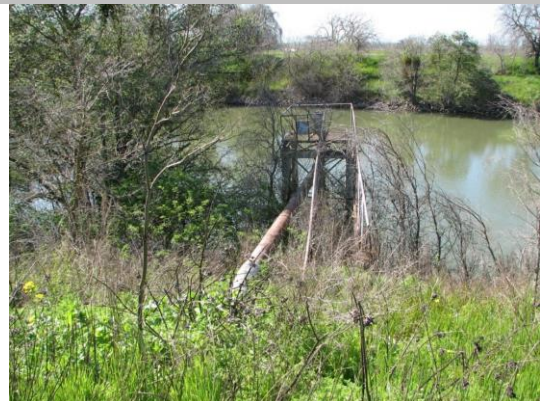
Photo 2 of 2 : UCIP\_SP\_2016\_43433\_70483.jpg

View of waterward side--pipe and remaining appurtenances.

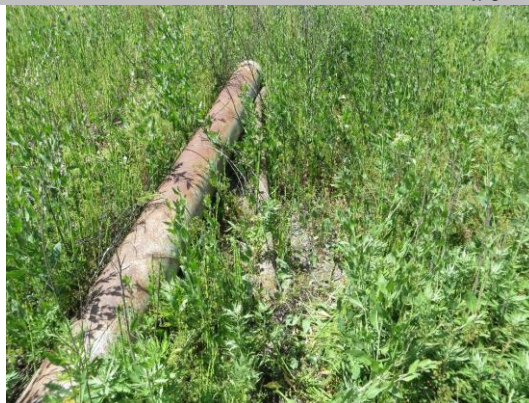
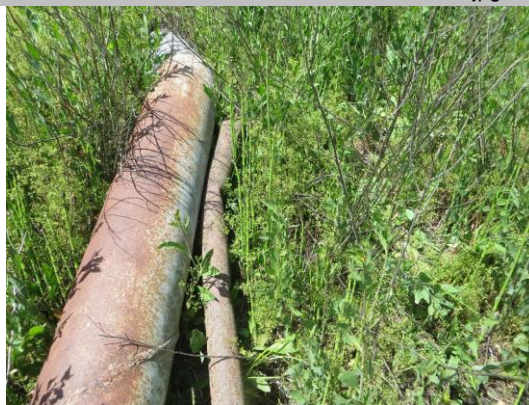
Photo 1 of 2 : UCIP\_SP\_2016\_44391\_73749.jpg

LM Start	5.19	Rating **	M	Issue No.	997
LM End	5.19	Issue Type +	En	Location *	CR
Category	Supplemental			GPS Latitude/Longitude	
				Start	End
Item	DWR UCIP Field Study			38.322460 °	38.322460 °
				-121.589690 °	-121.589690 °
DWR ID					
Comment Code					
Inspector Comment					
FS_ID:44391					
DS_ID:24189					
EP_NO: N/A					
Repair Type: Non-Urgent					
Crossing Status: Found					
UCIP Comments: Appears abandoned and if so should be done so properly.					
FIELD_STRUCT_DESC: 4-inch pipe through the levee, 3.3 feet below the crown. Gate and pump on platform at the landward toe (missing). Platform on the waterward side. (USACE-1959). This entry matches the Drainage or Irrigation Structure referenced in O&M manual (HLM 5.6).					
FS Date: 4/9/2015

4-inch pipe next to larger pipe on LS slope.

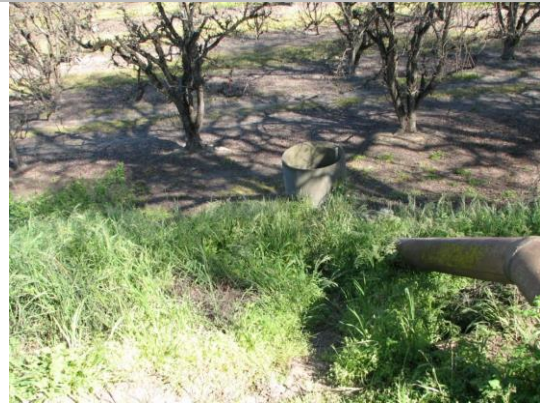
Photo 1 of 2 : UCIP\_SP\_2016\_43436\_36841.jpg

Comment Code					
Inspector Comment					
FS_ID:43436 DS_ID:24190 EP_NO: 16077 Repair Type: Urgent Crossing Status: Found UCIP Comments: Soil disturbed on landward slope--need to contact owner. Also vegetation limits the inspector's visibility to identify signs of pipe failure (leaks) along the slope. Recommend removing vegetation along pipe alignment to conduct proper inspection of structure and appurtenances. Note date on photos should be 3/18/09 not 7/26/08 camera metadata is incorrect. FIELD_STRUCT_DESC: 10-inch pipe through the levee, 3.8 feet below the crown. Pump in pumphouse on waterward side. Service pole on waterward slope. Concrete standpipe and distribution box at waterward toe. Pipe is exposed on both slopes. (USACE-1959). This entry matches the Drainage or Irrigation Structure referenced in O&M manual (HLM 5.9). Section of pipe under crown, between shoulders, removed and replaced with 10-inch steel pipe under Permit No. 16077 (2000). FS Date: 3/19/2009

View of landward--pipe and stand pipe visible.

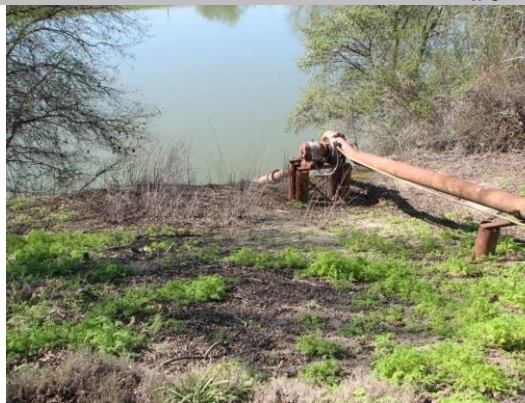
Photo 2 of 2 : UCIP\_SP\_2016\_43436\_36843.jpg

Item	DWR UCIP Field Study			38.326096 °	38.326096 °	
				-121.584747 °	-121.584747 °	
DWR ID						
Comment Code						
Inspector Comment						
FS_ID:43436 DS_ID:24190 EP_NO: 16077 Repair Type: Urgent Crossing Status: Found UCIP Comments: Soil disturbed on landward slope--need to contact owner. Also vegetation limits the inspector's visibility to identify signs of pipe failure (leaks) along the slope. Recommend removing vegetation along pipe alignment to conduct proper inspection of structure and appurtenances. Note date on photos should be 3/18/09 not 7/26/08 camera metadata is incorrect. FIELD_STRUCT_DESC: 10-inch pipe through the levee, 3.8 feet below the crown. Pump in pumphouse on waterward side. Service pole on waterward slope. Concrete standpipe and distribution box at waterward toe. Pipe is exposed on both slopes. (USACE-1959). This entry matches the Drainage or Irrigation Structure referenced in O&M manual (HLM 5.9). Section of pipe under crown, between shoulders, removed and replaced with 10-inch steel pipe under Permit No. 16077 (2000). FS Date: 3/19/2009

View of pipe and pump along waterward slope.
